Building Survey Report

Kincardine O'Neil Village Hall
55 North Deeside Road
Kincardine O'Neil

Date of Report: 26th August 2020

Job Ref: 20/62

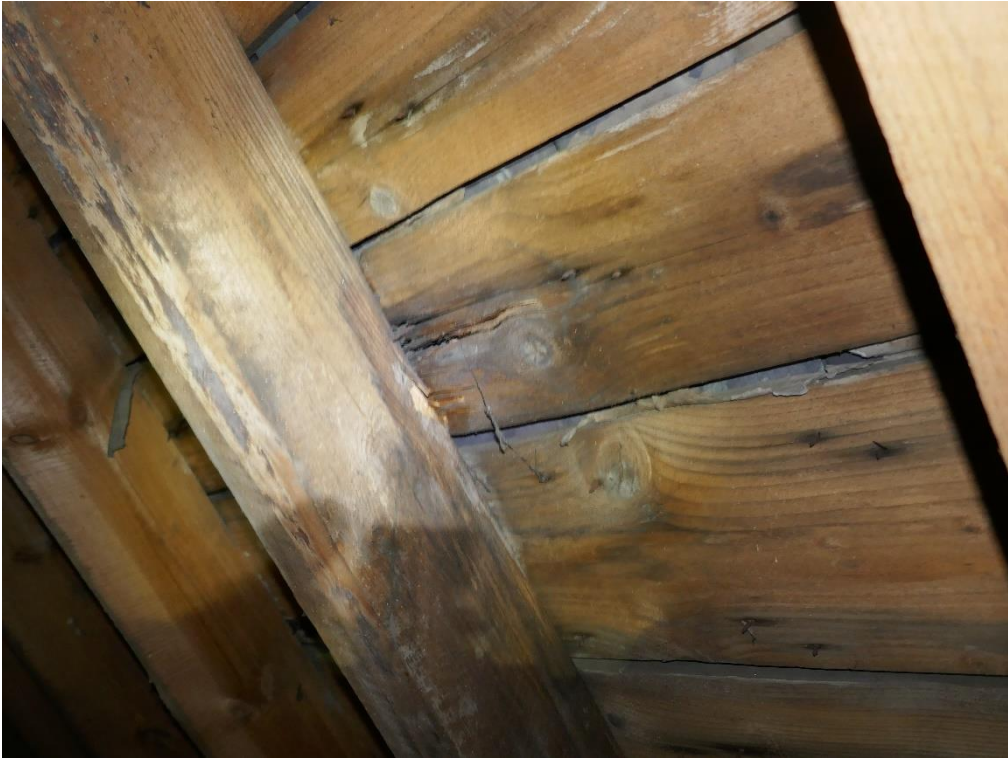
Photo 1

- 5.02 A small section of wet rot was noted affecting the timber sarking, and one of the rafters, on the east roof slope (Photo 1). This defect was noted back in 1997 and, whilst the extent of decay has not increased in the intervening period, we would recommend a localised repair be carried out to the rafter and sarking to avoid slates becoming dislodged due to the defective timbers.

- Minor wet rot repair to the roof sarking and rafters.
- 8.04 Repairs which would enhance the building and prolong its lifespan:-
- Wet rot repairs and redecoration of windows and doors.

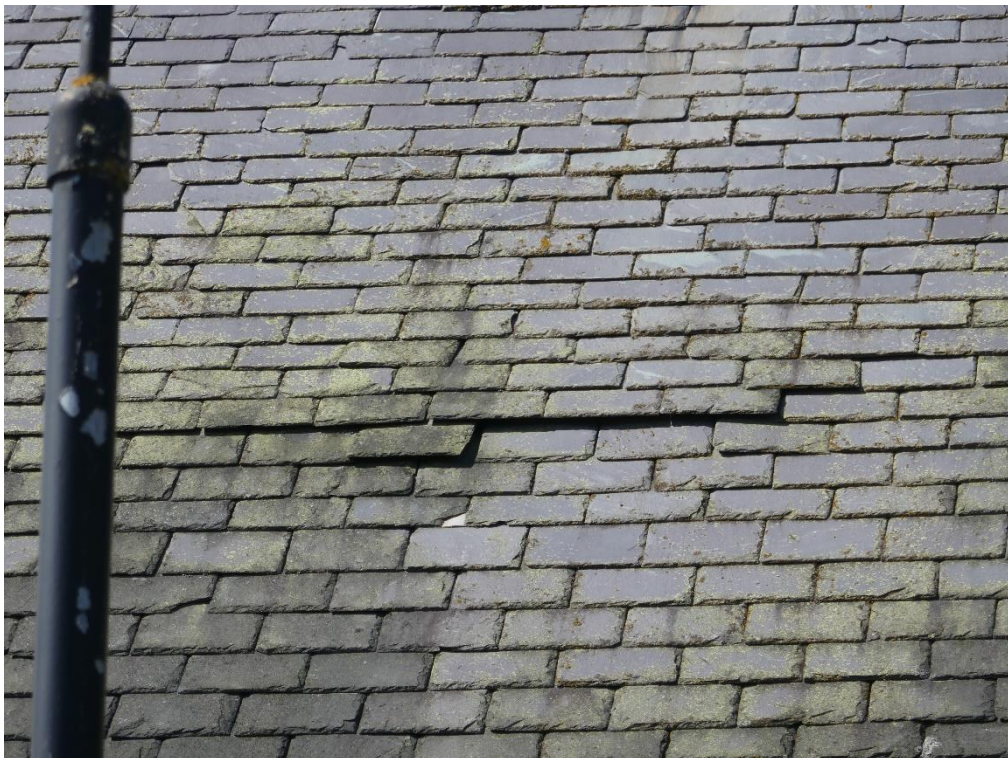
Photo 2

- 5.03 There are a number of slipped and loose slates on the roof and also an area on the East roof slope where there is an unexplained noticeable gap between the slate coursing (Photo 2).

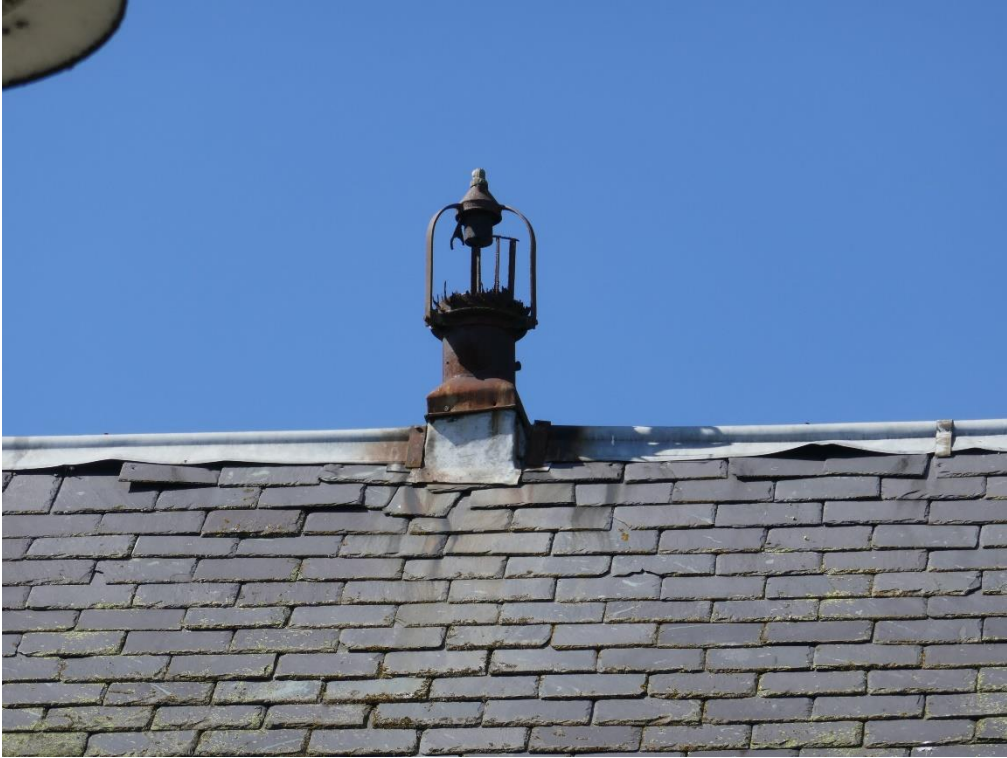
Photo 3

- 5.05 The 3no. metal rotating ventilation cowls on the roof ridge are in very poor condition, one of which has almost completely disintegrated (Photo 3). We are of the opinion that there is a danger that sections of the cowls could break loose and recommend that they are removed as soon as possible. The cowls sit at the head of ventilation ducts which are intended to naturally ventilate the hall. This type of ventilation may have been required in the past, when the hall was heavily used, however, in recent years the vents have been blocked up

with hinged flaps fitted at ceiling level. The blocking up of these vents would suggest that there is now little need for natural ventilation to the hall and the best course of action would be to remove the roof cowls and cap over the head of the ventilation ducts. If, however, it were considered necessary to provide some form of ventilation to the hall then a roof mounted electric extract fan could be fitted on the head of one of the ducts.

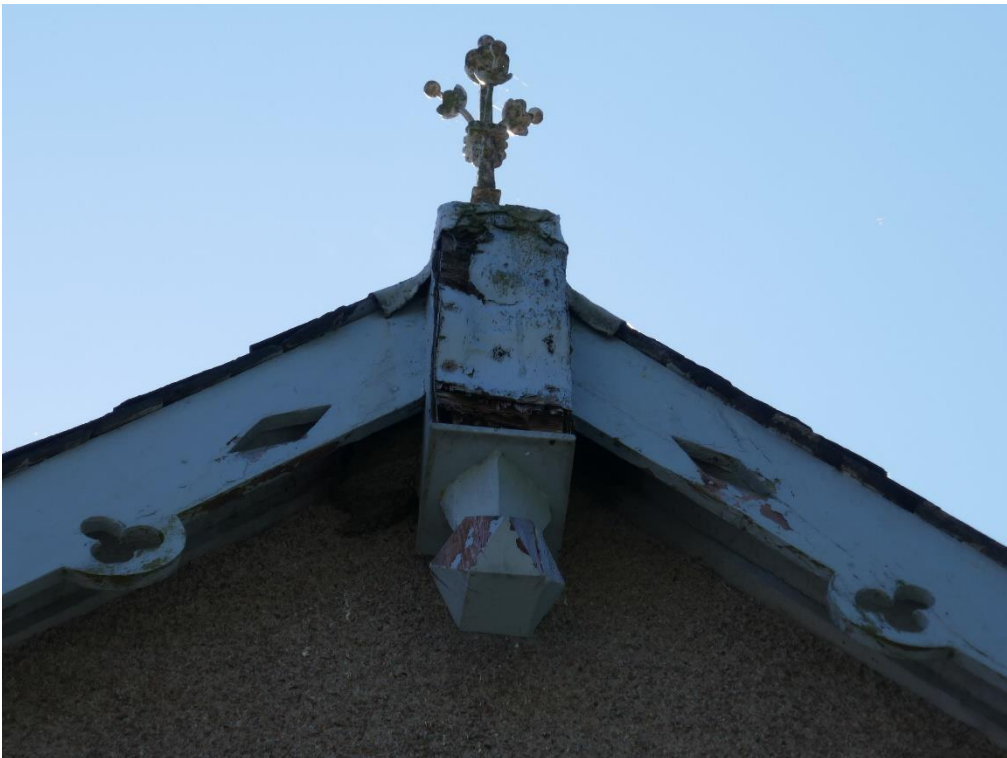
Photo 4

- 5.07 We noted some decay in the timber fascia boards and the decoration is poor to all the timber facias and barge boards to the roof.
- 5.08 There is extensive decay in the timbers to the support block for the metal ridge finial at the North end of the roof (Photo 4). We would recommend urgent action be taken to ensure that the finial is adequately secured and not in danger of falling.

- Repair/removal of the metal finial at the North end of the roof ridge.
 - Installation of a suitable fire alarm and emergency lighting.
- 8.02 Regular maintenance items:-

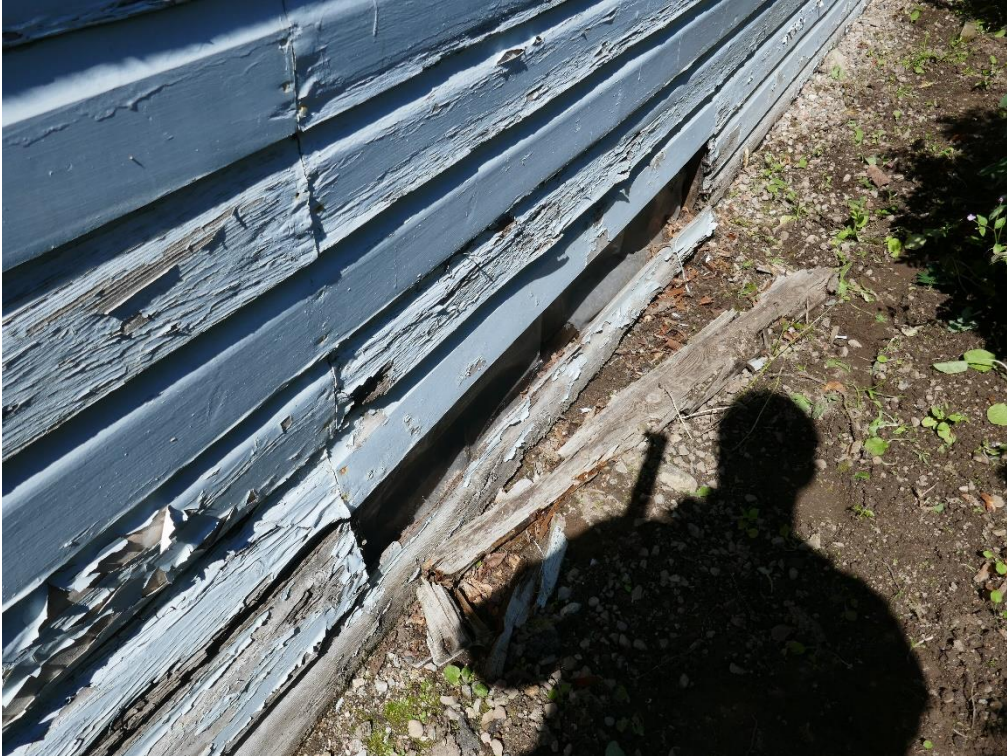
Photo 5

- 5.20 The timber ship lap boarding along the base of the East and West walls is in particularly poor condition, (Photo 5) which was also the case back in 1997. Considering the obvious lack of maintenance to the timbers, the extent of deterioration in the intervening years has been less than expected. We would suggest that with replacement of the badly decayed sections, and with regular decoration, the timber linings could be made to last the required 10 year period.

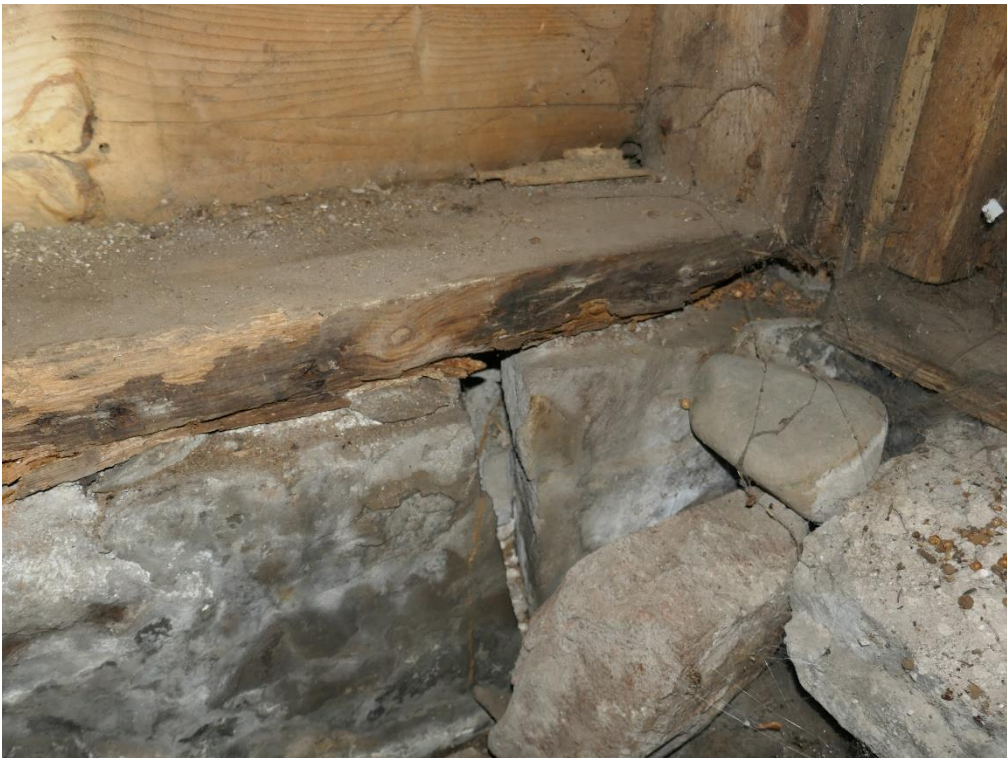
Photo 6

- 5.21 The wall plates within the rear extension are similarly affected by wet rot, again due to the lack of any damp proof course. (Photo 6) There is a dip in the line of the wall plate in the East wall where the soil pipe passes through the sleeper wall and inadequate support has been provided to the wall above. This defect was previously noted, however, there is no evidence of further deterioration in the intervening period.
- 5.22 The wall timbers are also affected by woodworm infestation and whilst heavy in areas, it is to a lesser extent than that within the main building. There would appear to have been limited further deterioration to the condition of the timbers since the date of our last report.
- 5.23 The drydash render is in reasonable condition with minor areas of hairline cracking and impact damage noted, none of which is of any structural significance.

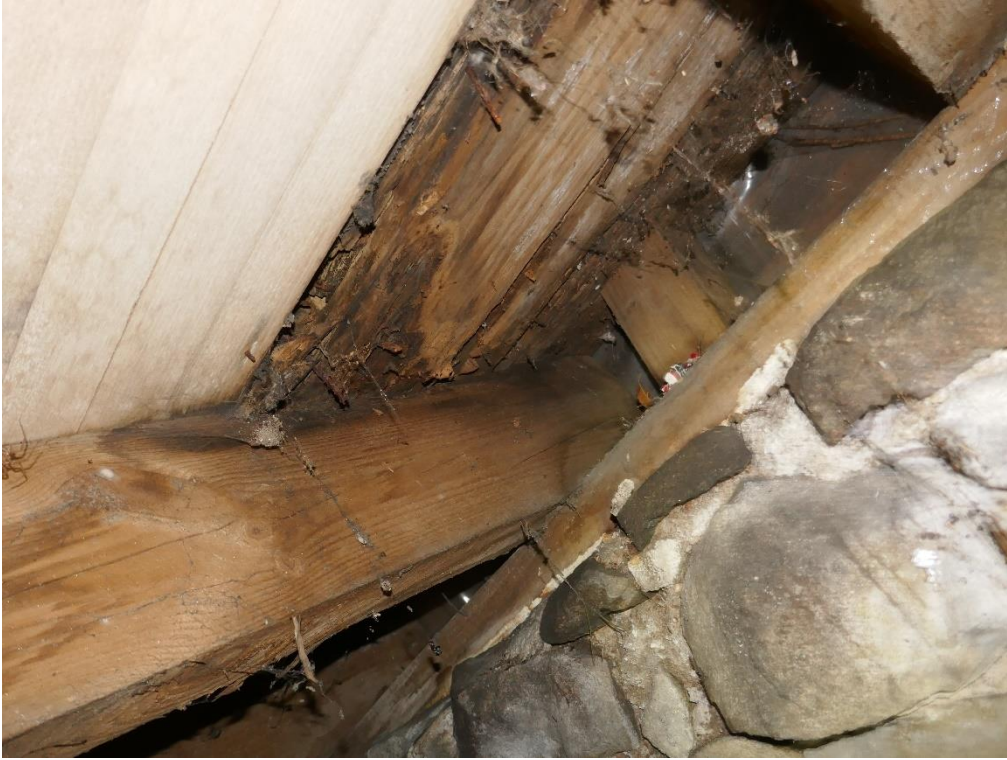
Photo 7

- 5.26 There is wet rot affecting a number of the joist ends, due to the external ground level being higher than the floor level in some areas (Photo 7). The floor joists are also affected by heavy woodworm infestation. The extent of the decay is worse than noted in our earlier report and we would therefore recommend that treatment and repairs should be undertaken to the worst affected timbers along the East side of the building.
- 5.27 The hardwood flooring is in fair condition; however, the floor finish is slightly uneven, and the board joints open in areas. Due to the moist untreated solum we are of the opinion that there will always be the possibility of the floorboards twisting or warping due to the damp environment.
- 5.28 The flooring to the stage area would appear to be original and is generally well worn and uneven.

- 8.03 Repairs recommended to delay further deterioration of the structural fabric:-
- Wet rot repairs to the wall framing and floor joists along the East elevation.
